NORTON CO. WORCESTER MASS INDUSTRIAL CERAMICS DIV  
SEVERE ENVIRONMENT TESTING OF SILICON NITRIDE ROLLING ELEMENTS.--ETC(U)  
NOV 79 J W LUCEK, L B SIBLEY, J W ROSENLIB N00019-77-C-0551

REPORT DOCUMENTATION PAGE		READ INSTRUCTIONS BEFORE COMPLETING FORM
1. REPORT NUMBER	2. GOVT ACCESSION NO.	3. RECIPIENT'S CATALOG NUMBER
4. TITLE (and Subtitle) SEVERE ENVIRONMENT TESTING OF SILICON NITRIDE ROLLING ELEMENTS		5. TYPE OF REPORT & PERIOD COVERED FINAL rept. 30 DEC 77 - 2 MAR 79

This report describes efforts carried out under Naval Air Systems Command contract NASC N00019-77-C-0551 for the period 30 December 1977 through 2 March 1979. The objective was to study the behavior of silicon nitride rolling contacts in severe; high temperature, dry film lubricated conditions.

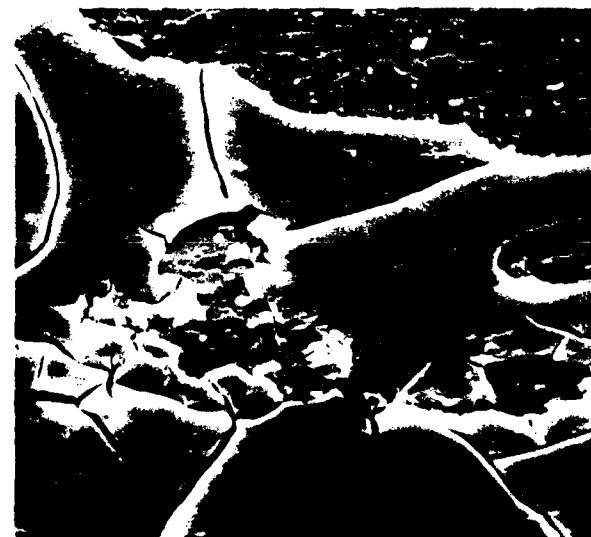
a. Center of ball track from  
Test 3-1

c. Center of ball track from  
Test 3-2

d. High magnification of  
Figure 3c

FIGURE 13 - Comparison of wear tracks on NC-132 spindle balls  
tested with MoS<sub>2</sub> sputter coated orbital balls  
and graphite cage

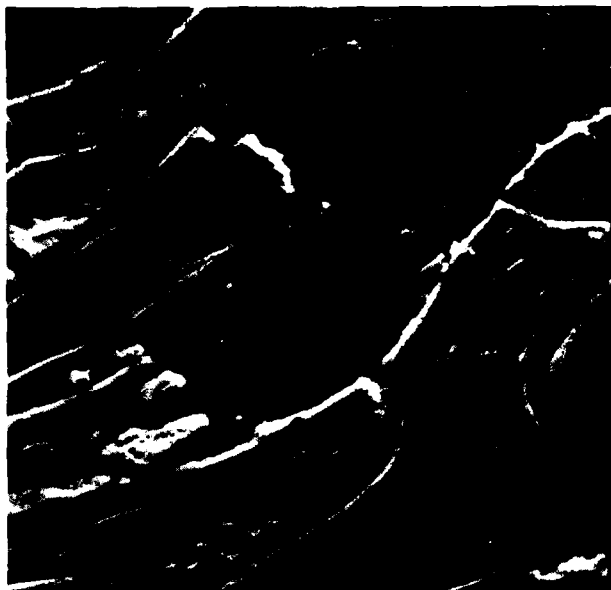
a. SEM photo of surface in center of ball wear track (SE)

b. Silicon concentration map of view in a

c. Molybdenum concentration map of view in a

FIGURE 15 - SEM & microprobe analysis of surface layer on NC-132 spindle ball track after Test 3-2 with  $\text{MoS}_2$  sputter coated orbital balls and graphite cage.

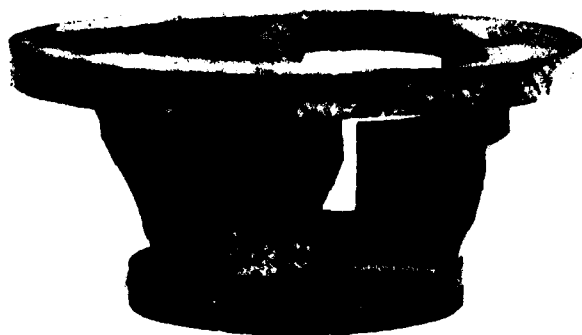
a. Heavy wear in cage pocket 1.7X

b. SEM photo of surface in center of ball wear track 1000X

c. Silicon concentration map of view b. 1000X

d. Carbon concentration map of view in b. 1000X

FIGURE 17 - Cage pocket wear and x-ray analysis of deposits on wear track of NC-132 spindle ball after Test 1-6 at 540°C (1000°F) with uncoated balls and graphite cage.

Figure 17 shows very distinctly the graphite deposits on the spindle ball track from the heavy cage pocket wear in the 540°C uncoated ball test (1-6). This graphite obviously is not adherent enough to prevent silicon nitride wear. The pattern on the silicon map in Figure 17c indicates that other species are present on the worn silicon nitride surface, which was not explored further in this analysis. Even though there was heavy
